Dredging Research **Technical Notes**

Field Evaluation of Endeco Model 1029 Tide Gage

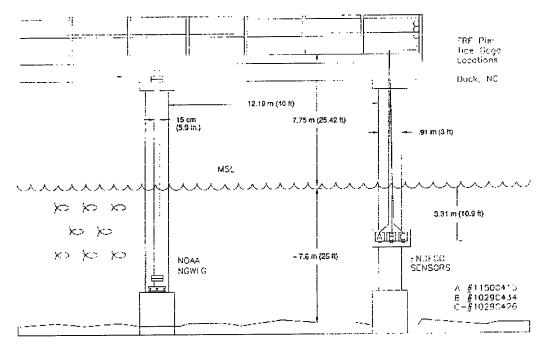
Figure 1. Diagram showing sensor location on pier

The Endeco gage sensors were oriented vertically and mounted side by side on a single flat plate. The plate was then installed on the pier support piling (Figure 1) and leveled. Care was taken to ensure that all three sensors were at the same vertical level. Measurements from the top of the pier to the bottom of the sensor housings indicated that the sensors were 3.3 m (10.8 ft) below National Geodetic Vertical Datum (NGVD). Both Endeco and NOAA data were adjusted to NGVD to allow a direct comparison.
